State of Utah **DEPARTMENT OF NATURAL RESOURCES** Division of Oil, Gas & Mining

Inspection Report

Mine Name: Dry Wash	Permit number: S0150096
Withe Maine: Dry Wash	reimit number: 30130090
Operator Name: Miracle Rock Mining	Inspection Date: April 21, 200
	Time: 2:15-2:50 PM
Inspector(s): Paul Baker

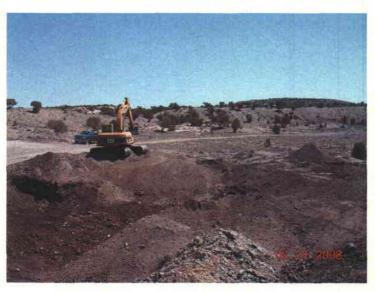
As can be seen in the photos, the operator has pulled back soil and overburden and is mining with a trackhoe.

Photo 1. The active mining area.

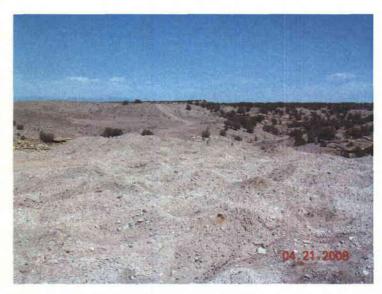
The mine contains two areas separated by a road. The more recent disturbance is on the west side of the road. It appears the operator has pulled back a spoil pile in the area on the east side of the road although it did not appear to have been seeded.

Photo 2. This is an area where I thought it looked like overburden had been pulled back, possibly in preparation for, or as part of, reclamation.

The operation appears to be in compliance with the rules. As areas become available, I suggest the operator do as much contemporaneous reclamation as possible, but surface preparation and seeding should be done in the fall.

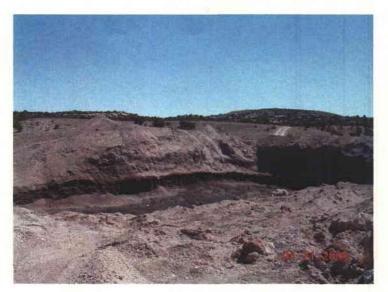
Photo 3. The older pit on the east side of the road.

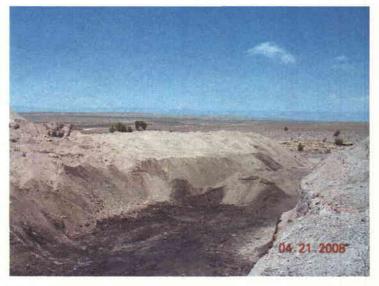
Photo 4. Another view of the older pit.

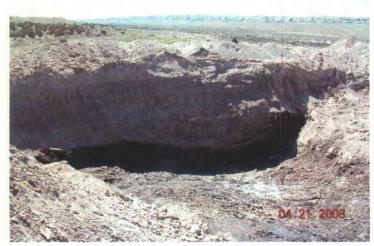
Photo 5. The ore within the older pit.

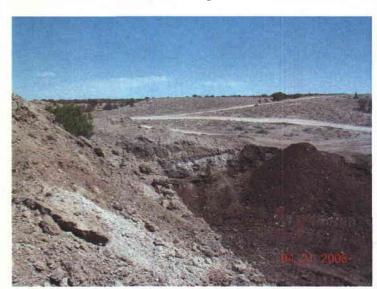
Photo 6. Overburden on the left, ore on the right in the newer pit.
